Manhole Inspection Summary

Manhole # S15AA2010MH

Insp Date: **10/2/06 10:51 AM**

Location Address: **5602 WEXFORD RD**

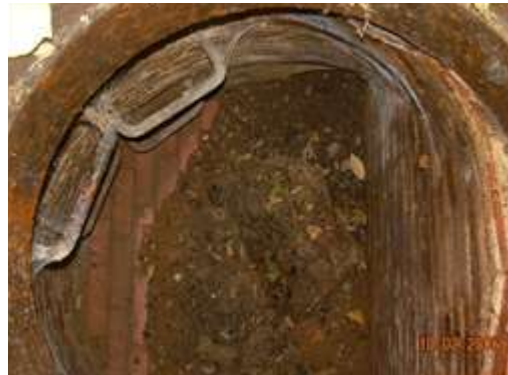
Top View

Frame leak. Corroded steps. Channel debris

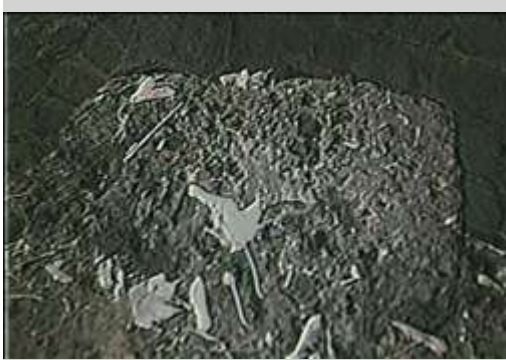
Defect

Large rock in Channel.

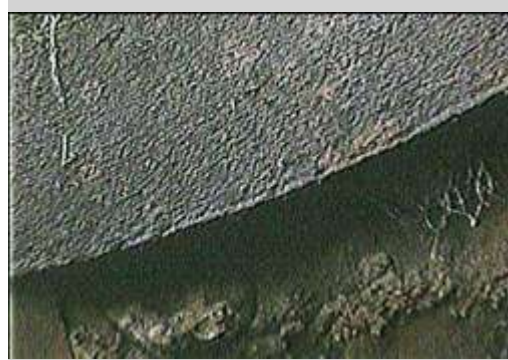
Defect

Adjustment deterioration and infiltration.

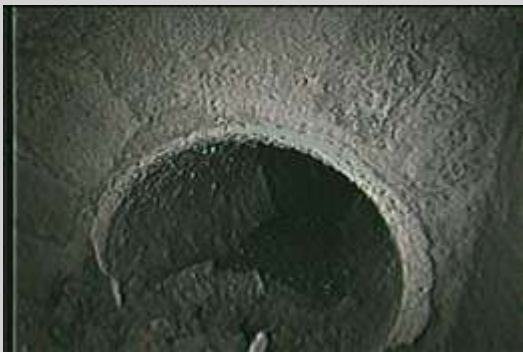
8 in. Circular Gravity Sewer
Pipe Out @ 12 O'Clock

Deposits: ☐ None ☒ **Mud** ☐ Sludge ☒ **Debris** ☐ Grease

Silt Depth: **1** (in.) Deposits Extent: **Light**
